# Accidental Overexposure of Radiotherapy Patients in Białystok

ACCIDENTAL OVEREXPOSURE  
OF RADIOTHERAPY PATIENTS  
IN BIAŁYSTOK

© IAEA, 2004

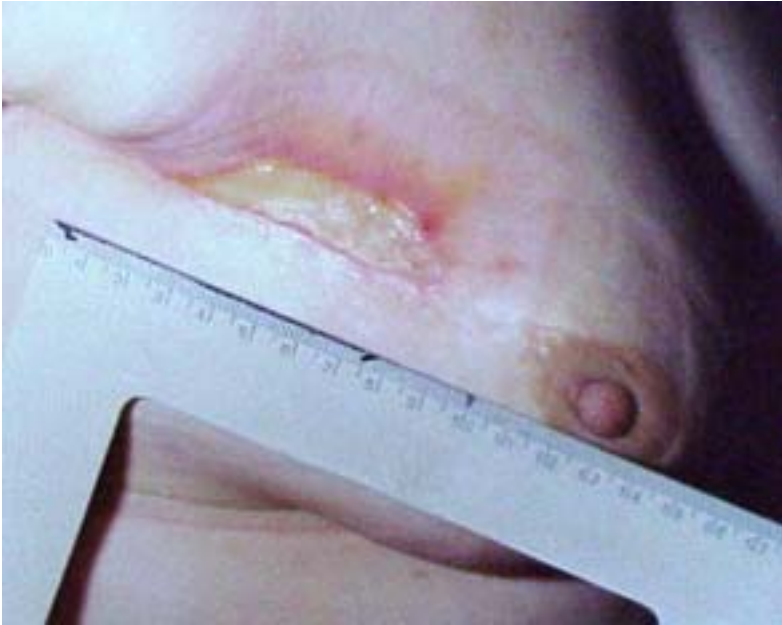
*FIG. 12. Patient 1 on 4 June 2001: Ulcerated subaxillary area (4.5 mm × 18 mm).*

topical treatment at home. An examination performed in June showed that the ulcerated area measured 4.5 mm × 18 mm (Fig. 12).

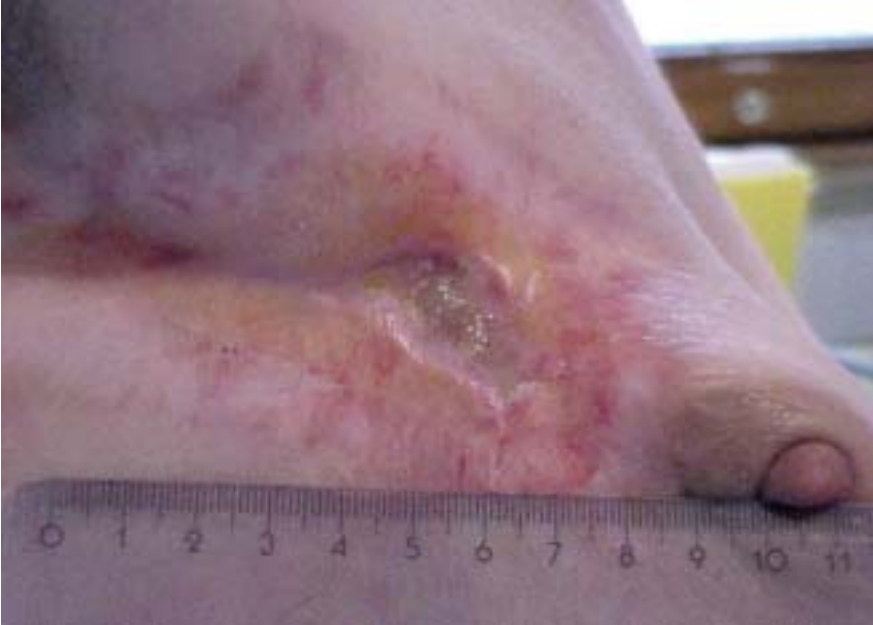
Examination by the IAEA expert medical team on 30 November and 1 December revealed a 3.5 cm × 1.5 cm ulcerated lesion along the axis of the surgical scar (Fig. 13). The centre of the ulcer was 6 cm superior and lateral to

*FIG. 13. Patient 1 in December 2001: Ulcerated lesion (3.5 cm × 1.5 cm) along the axis of the surgical scar.*

the nipple. There was a 1 cm border of induration surrounding the ulcer and there were minor areas of telangiectasia in the axilla.

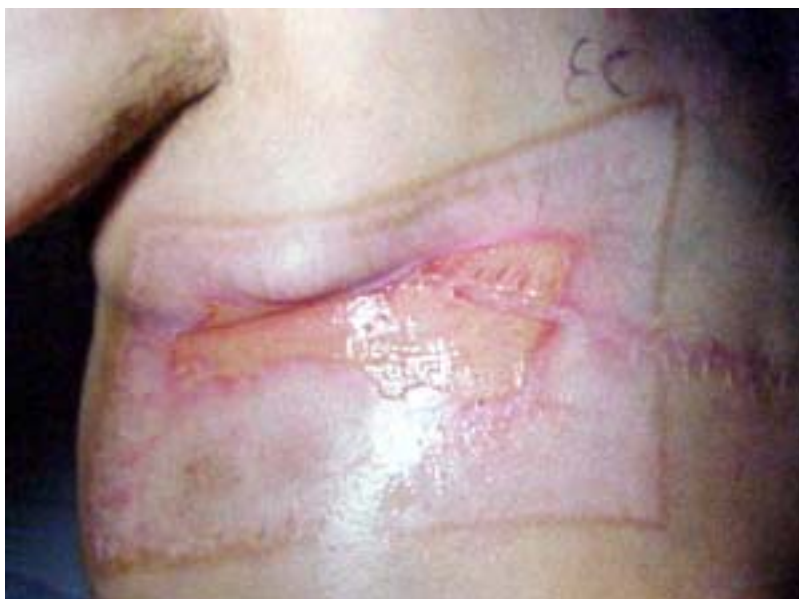
On 5 March, the patient began to experience pain at the site irradiated by the electron beam. She was admitted to the BOC on 12 March for one month. The irradiated site had a pale white appearance just inside the field margins. Therapy included administration of Linomag topical ointment; Solcoseryl; vitamin PP (nicotinic acid); vitamins B1, A and E; and topical corticosteroids. On 4 June, a 5 cm  $\times$  10 cm area of desquamation was detected in the central zone of the 10 cm  $\times$  14 cm depigmented area (Fig. 14).

*FIG. 14. Patient 2 on 4 June 2001: Moist desquamation area measuring 5 cm × 10 cm in the centre of a 10 cm × 14 cm depigmented field in the zone of the mastectomy.*

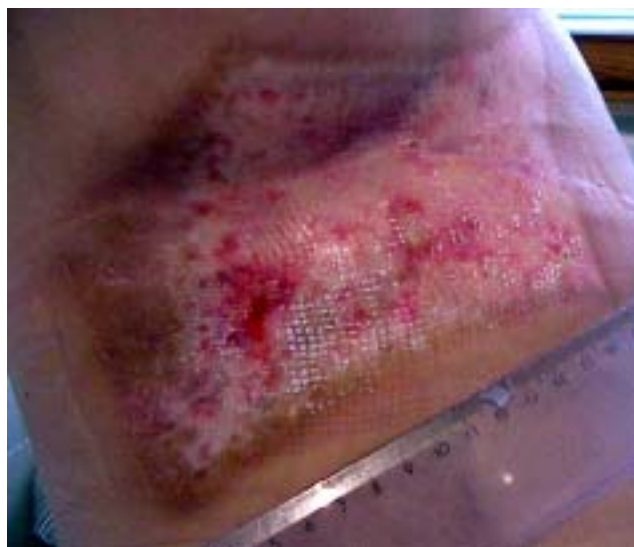
HBO therapy began on 6 November and ended on 21 December 2001. Between 6 November and 19 November, the treatment was performed twice daily; from 20 November to 21 December it was performed once per day. The total number of exposition sessions was 46. Effective inhalation with 100% oxygen at a pressure of 2.5 bar resulted in a session lasting 75 minutes. It was concluded that HBO therapy led to local improvement in the three weeks following commencement of the treatment. Examination of the patient by the IAEA expert medical team on 30 November and 1 December 2001 revealed a 14 cm × 10 cm area that was pale, exhibited poor epithelialization and showed serous exudation and multiple punctate areas of bleeding. The superficial tissues appeared to be fixed to the chest wall. There were no obvious areas of necrosis or infection (Fig. 15).

*FIG. 15. Patient 2 on 1 December 2001: Depigmented area (14 cm × 10 cm) exhibiting poor epithelialization, marked exudation and multiple punctate areas of bleeding without obvious areas of necrosis or infection.*

The IAEA expert medical team concluded that at the time of the examination, surgery did not appear to be necessary; the patient's injury could possibly heal with conservative treatment or it might need reconstructive surgery based upon the future progression and expression of underlying vascular injury. It was recommended that administration of Pentoxifylline (800–1200 mg/d) and Tocopherol (400–500 mg/d) be continued for a total treatment time of at least one year.

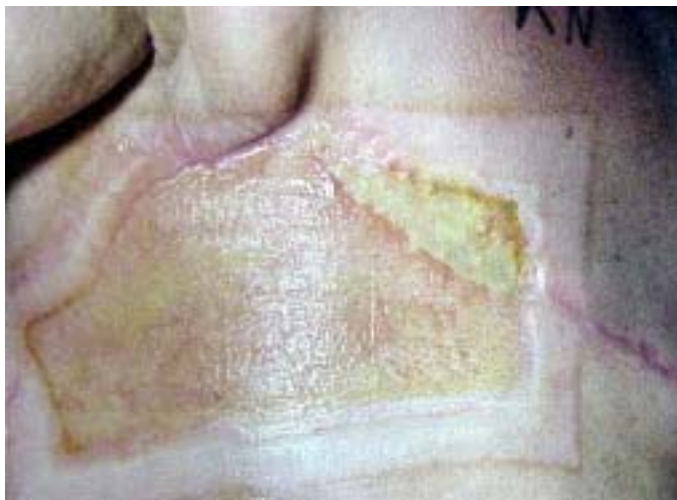
On 23 April, Patient 3 was readmitted to hospital with a fever. She was given a systemic course of corticosteroids following which she developed steroid induced diabetes that required treatment with insulin. A CT scan on 2 May showed some pericardial fluid and a reaction in the antero-lateral right chest wall. Rehabilitation began in May. At this time the skin of the irradiated field showed a white ‘frame’ with a slight pinkness in the centre and this was accompanied by moderate pain. In June, ulceration was noted in the centre of the field at the surgical scar (Fig. 16).

*FIG. 16. Patient 3 on 4 June 2001: Superficial ulceration (3 cm × 7 cm) close to the medial edge of the irradiated field along the surgical scar.*

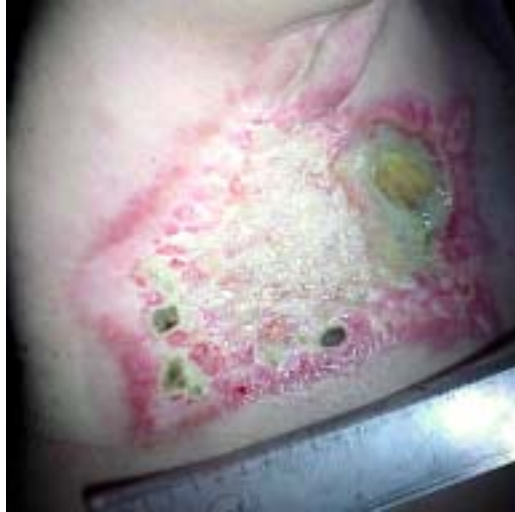
*FIG. 17. Patient 3 on 1 December 2001: A 16 cm × 8 cm area which had islands of re-epithelialization and small (less than 1 cm × 1 cm), scattered areas of necrosis and ulceration.*

Examination of the patient by the IAEA expert medical team on 30 November and 1 December revealed a 16 cm × 8 cm area which had islands of re-epithelialization and small (less than 1 cm × 1 cm), scattered areas of necrosis and ulceration. At the site of the surgical scar there was a 3 cm × 4 cm ulcer with a deeper central portion of 2 cm × 3 cm that extended to the underlying rib (Fig. 17).

The IAEA expert medical team concluded that at the time of examination the patient had very serious injuries that probably would not heal without intervention. The team observed glucosuria, which was considered as most probably of a transient nature and due to corticosteroids, but which could also have been of diabetic origin. The team recommended:

- (a) Assessment of the extent of the radiation necrosis through the chest wall, with particular emphasis on the ribs, using NMR;
- (b) Cessation of HBO therapy after completion of the protocol, as it did not significantly improve the clinical situation during the elapsed month;
- (c) Continuation of Pentoxifylline/Tocopherol therapy in order to reduce the extent of long term residual fibrosis;
- (d) Consideration of surgical treatment at the earliest opportunity in order to avoid development of a catastrophic complication such as pneumothorax.

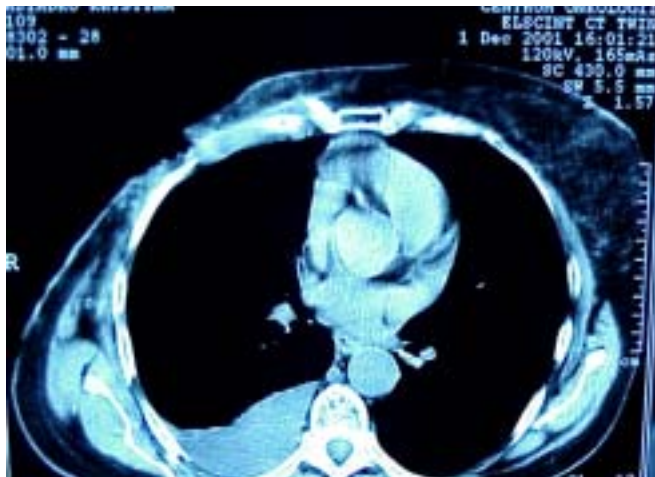
The IAEA expert medical team obtained a new, non-contrasted chest CT scan on 1 December, which showed that the distance between the deep portion of the ulcer and the lung was only 1 cm. It also showed a moderate size fluid collection in the right pleural cavity (Fig. 18).

*FIG. 18. CT scan of Patient 3 performed on 1 December 2001.*

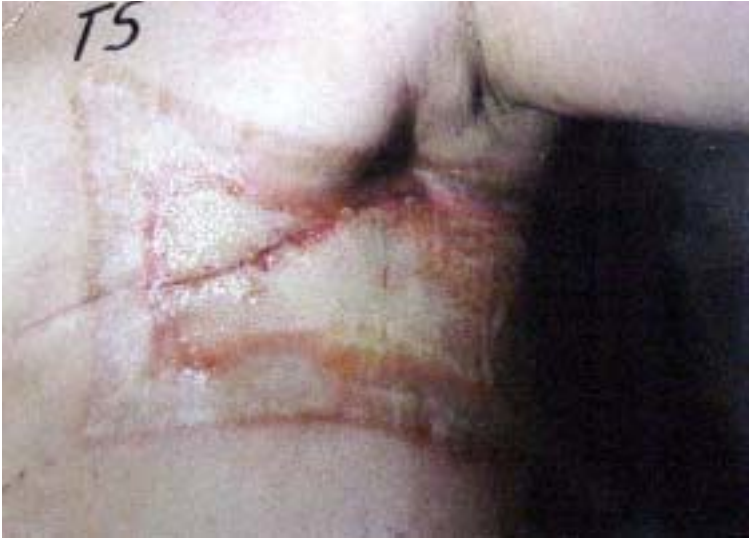
*FIG. 19. Patient 4 on 4 June 2001: Moist desquamation in the irradiated area, following mastectomy to the left side.*

The patient was hospitalized at the Centre of Oncology (Warsaw) in May for rehabilitation and pain management. On 4 June, only moist desquamation with small erosions along the surgical scar was seen in the irradiated field (Fig. 19).

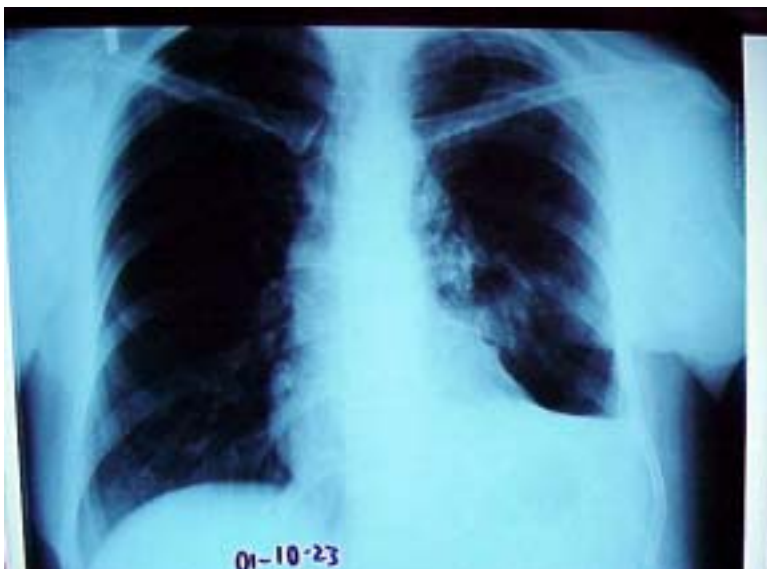
Patient 4 was readmitted to hospital in Warsaw in September for several days to obtain additional rehabilitation treatment. In October, the lesion became much worse. Debridement of a necrotic lesion was performed and staphylococcus aureus was cultured from the wound. The patient developed a large pleural effusion in October 2001 (Fig. 20) and a litre of fluid, which was negative for malignant cells, was removed from the lesion.

*FIG. 20. Patient 4 on 23 October 2001: A large pleural effusion is visible on the left side of the chest X ray.*

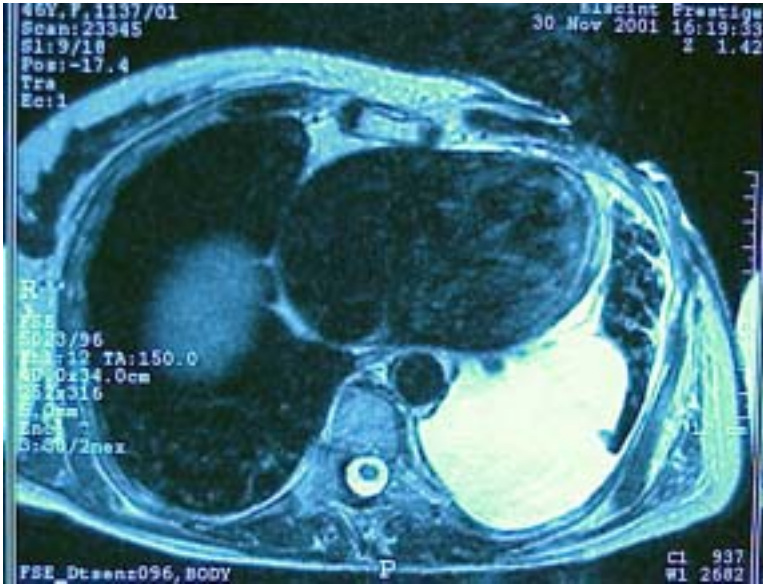
Examination of the patient by the IAEA expert medical team on 30 November and 1 December revealed that the general health status of the patient was fair. There was no dyspnoea, chest pain or cough. On palpation, the right breast was normal. The regional lymph nodes, liver and spleen were not enlarged. The function of the left arm was satisfactory, but the range of movement was slightly limited. Auscultation revealed dullness at the base of the left lung and a moderate to large pleural fluid collection in the left pleural cavity that had apparently reaccumulated (Fig. 21).

FIG. 21. Patient 4 on 30 November 2001: CT scan of thorax showing a large pleural effusion.

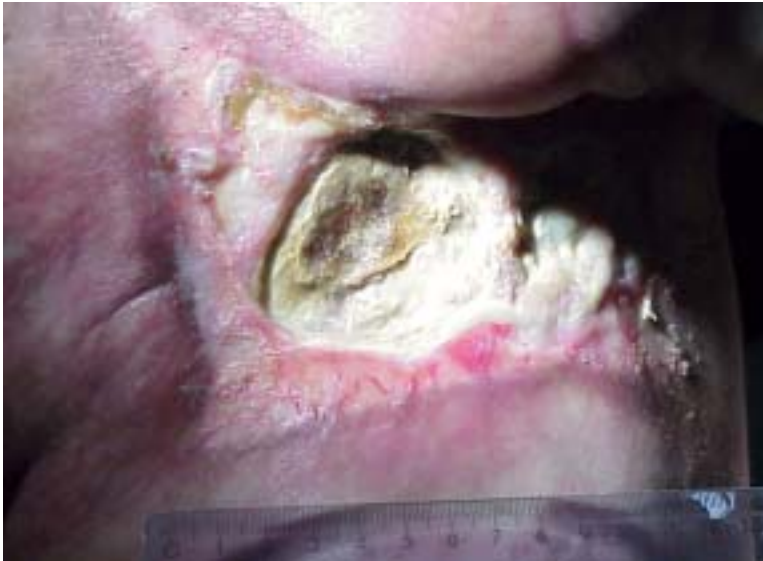
A radiation reaction of the skin and subcutaneous tissue ranging from Grades II to IV was noted in the irradiated field in the left area of the chest. The skin changes covered an area of 14 cm  $\times$  8 cm and in the centre of this area lay an ulcer of full thickness covering an area of 5 cm  $\times$  4 cm (Fig. 22).

The IAEA expert medical team concluded that at the time of examination the patient had very serious injuries that would not heal without intervention. The team recommended exploring for possible necrosis to the rib resulting from overexposure to radiation and myocardial damage using NMR. It was proposed that surgical treatment be considered at the earliest opportunity in order to avoid a catastrophic complication. Bearing in mind the decision to be taken regarding surgery, the team pointed out that as Patient 4 had deep necrotic lesions in the thin chest wall just above the heart she would be at additional risk from potential radiation induced cardiac injury.

FIG. 22. Patient 4 on 1 December 2001: Severe skin changes following a radiation burn. The wound covers an area of 14 cm × 8 cm; in its centre lies an ulcer of full thickness covering an area of 5 cm × 4 cm.

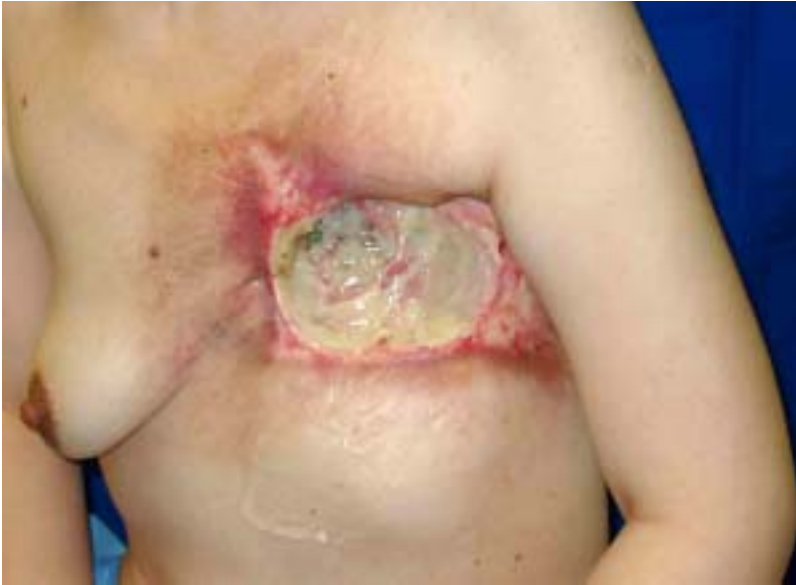
*FIG. 23. Patient 4 in May 2002: Local injury before reparative surgery.*

all the thickness of the left chest wall in the internal two thirds of the electron field, and severe superinfection by *pseudomonas aeruginosa*. The beating heart of Patient 4 was visible in the depth of the wound. The status of the local injury is shown in Fig. 23.

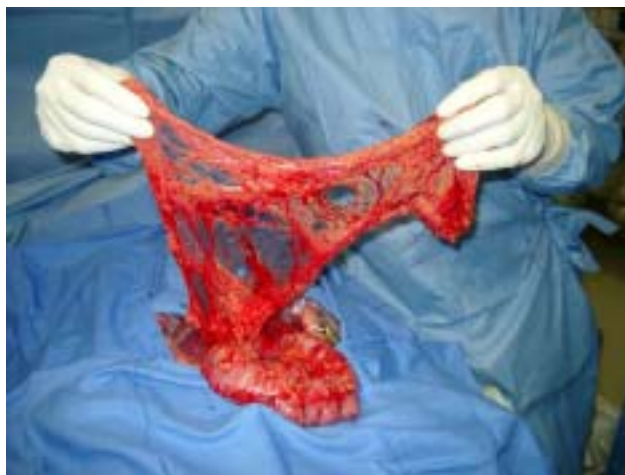
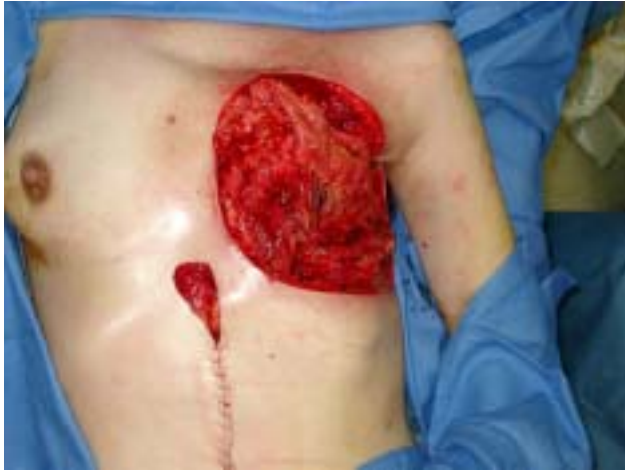
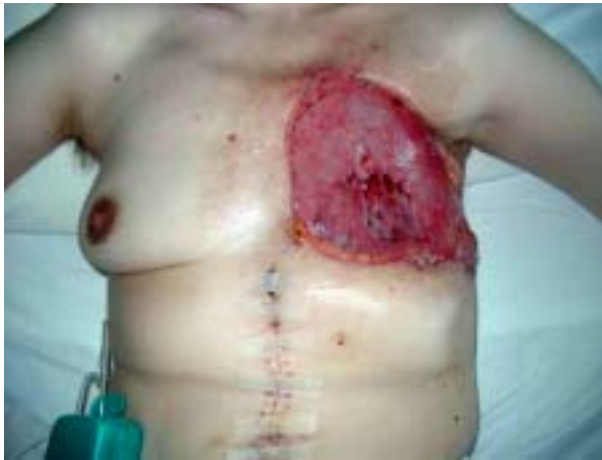
*FIG. 24. Stages of surgery for Patient 4: Preparation of a large omentum flap.*

*FIG. 25. Stages of surgery for Patient 4: Defect covered with an omentum flap.*

*FIG. 26. Stages of surgery for Patient 4: End of operation.*

abdomen, preparation of a large omentum flap, large ablation of all the necrotic and preneurotic tissues of the left anterior chest wall, and positioning of the omentum flap brought from the abdomen through a subcutaneous tunnel. Histological analysis of large necrotic lesions showed no trace of tumour. Three stages of this surgery are illustrated in Figs 24–26.

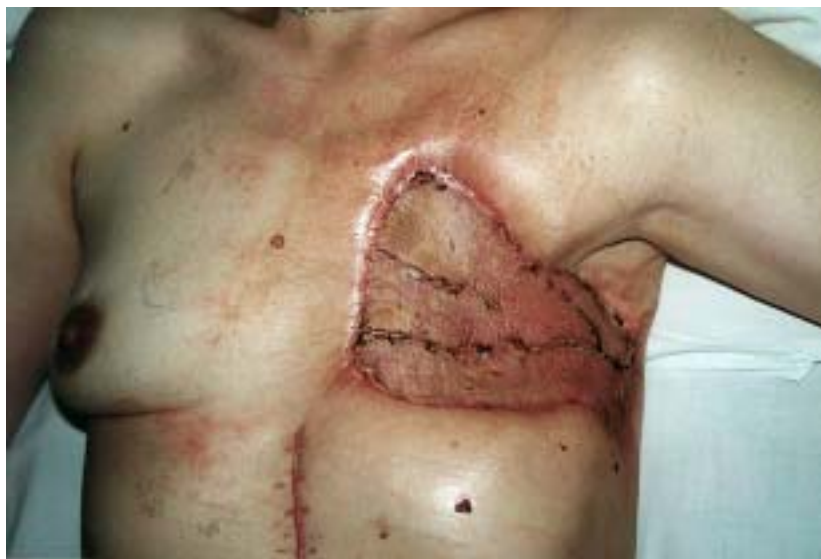
*FIG. 27. Outcome of the two step surgery on Patient 4 at the Institut Curie, July 2000. The secondary defect has been covered by a free skin graft.*

In the early follow-up, it was observed that the omentum flap was accepted very well, with rapid cell proliferation and a ‘filling in’ of the wound. On 4 July, when the proliferation of the omentum flap was satisfactory, Patient 4 underwent her second reparative operation<sup>16</sup>, which consisted of positioning a free skin graft (taken from the anterior part of the right thigh) on the omentum flap. Figure 27 presents the conditions of local injury after the treatment.

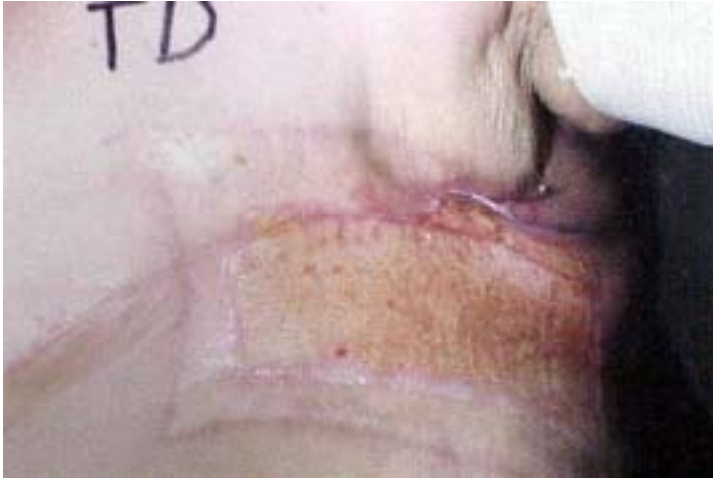
*FIG. 28. Patient 5 on June 2001: The 7 cm × 14 cm central part of the 11 cm × 18 cm irradiated area became hardened, fibrotic in the centre and surrounded by a depigmented border.*

Two weeks after the exposure, a slight erythema developed, turning to dry and moist desquamation during the following two weeks. Beginning in early April, epithelialization progressed, but Patient 5 felt a severe pain in the irradiated field, which seemed to be out of proportion to the clinically observed skin findings. In May, the irradiated area became fibrotic in the centre with a somewhat indistinct white border (Fig. 28).

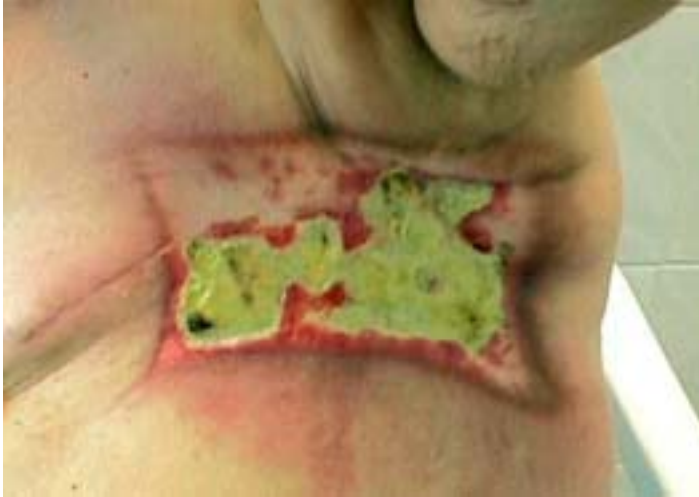
Owing to her social conditions, Patient 5 stayed without interruption in hospitals between February and September 2001. The local injury in the irradiated field became infected in the middle of October and the infection spread quickly. A small area of necrosis (1.5 cm × 1.5 cm) appeared at the medial line of the wound (Fig. 29).

*FIG. 29. Patient 5 on 6 November 2001: Highly infected local radiation burn (6 cm × 13 cm) in the area of the left mastectomy.*

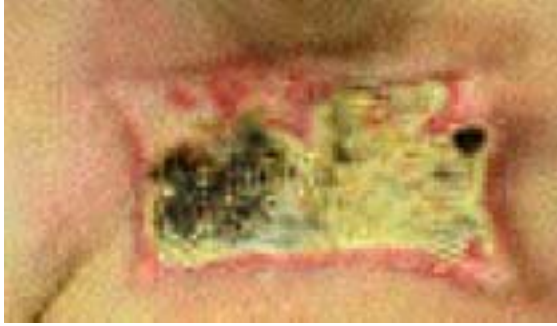
ulceration progressed over the ensuing month. The area of necrosis at the medial line increased to 5 cm × 5 cm. Other areas of necrosis (2–3 small necrotic foci) also appeared (Fig. 30).

*FIG. 30. Patient 5 on 20 November 2001: Superinfected necrotic radiation burn (7 cm × 13 cm) in the area of the left mastectomy.*

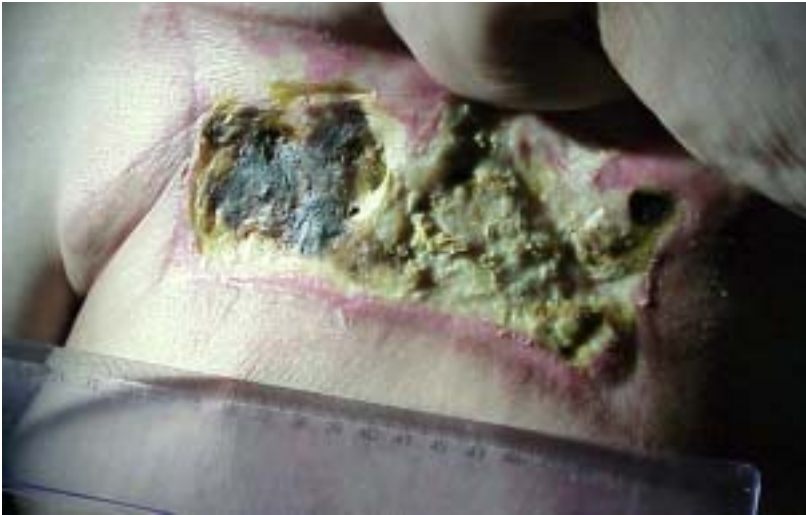
Examination of the patient by the IAEA expert medical team on 30 November and 1 December revealed a large area (14 cm × 7 cm) of Grades III and IV radiation injury. In the area of the surgical scar there was a 5 cm × 5 cm necrotic lesion exhibiting a black colouration and of full thickness extending down to the ribs (Fig. 31).

The IAEA expert medical team concluded that at the time of examination the patient had very serious injuries. The conditions of treatment were complicated by the presence of concomitant diabetes mellitus. Surgical treatment was proposed as a matter of urgency. The team noted that the patient had a higher risk of becoming septicemic because of her diabetes. In addition, diabetes would make surgery and healing difficult, and a successful outcome uncertain. As with Patient 4, it was noted that Patient 5 presented deep necrotic lesions in the thin chest wall just above the heart, and therefore was at

*FIG. 31. Patient 5 on 1 December 2001: A large area (14 cm × 7 cm) of radiation injury of Grades III and IV.*

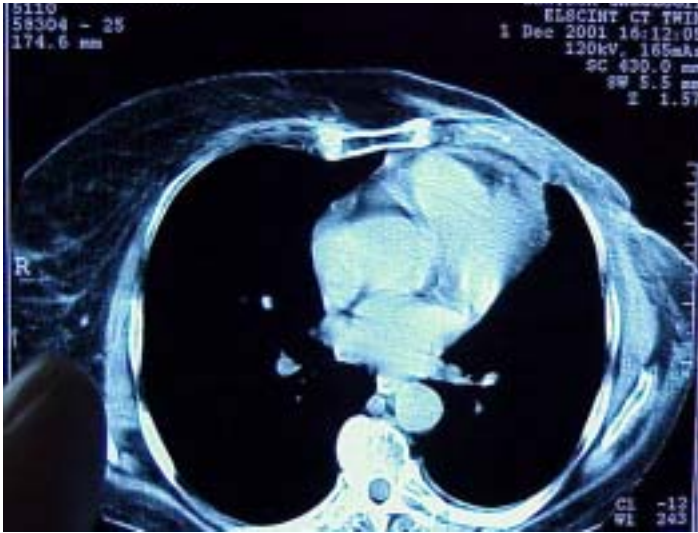
A non-contrasted CT scan of the chest was requested by the team. The scan, which was performed on 1 December, revealed a small pericardial effusion. In addition, it showed that the apex of the left ventricle of the heart lay directly under the necrotic lesion and was slightly deformed by a focal bulge (Fig. 32).

FIG. 32. Patient 5 on 1 December 2001: CT scan of the chest.

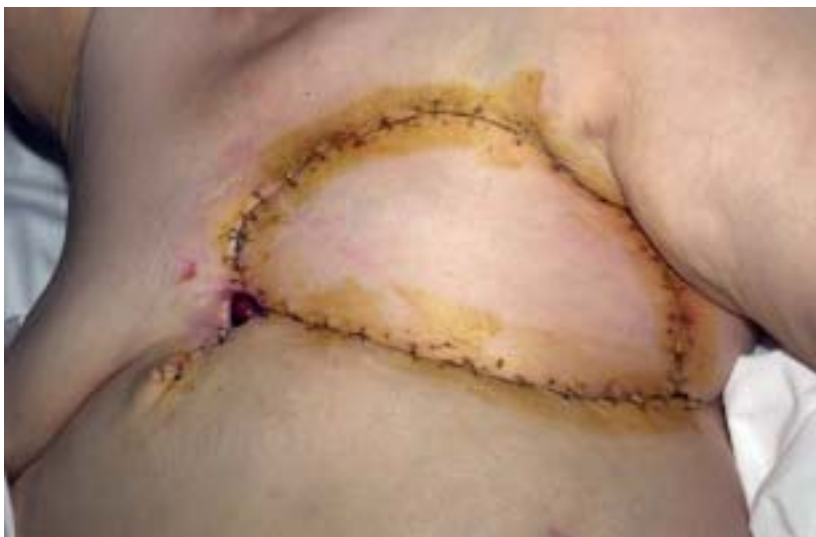
*FIG. 33. Results of the one step surgery on Patient 5 at the Institut Curie, October 2002.*

The decision was made to attempt a dorsal pedicled flap, after local preparation. The patient underwent a one step operation on 30 September 2002.<sup>18</sup> The operation consisted of making a wide excision of all the necrotic and pre-necrotic tissues (precisely identified by MRI and CT). Samples of the excised tissues were taken for analysis at the laboratories of the Institut de Radioprotection et de Sûreté Nucléaire and of the Commissariat à l'Énergie Atomique/Direction des Sciences du Vivant. Owing to the macroscopical aspect of the anterior parts of the 3rd, 4th, 5th and 6th ribs, they were completely resected. Removal of tissues stopped at the pleural and pericardial levels (which were not involved). A musculo-cutaneous flap (latissimus dorsi) was then prepared, along with its vascular pedicle. The flap adequately covered all the resected area. The immediate results of the surgery were satisfactory (Fig. 33).

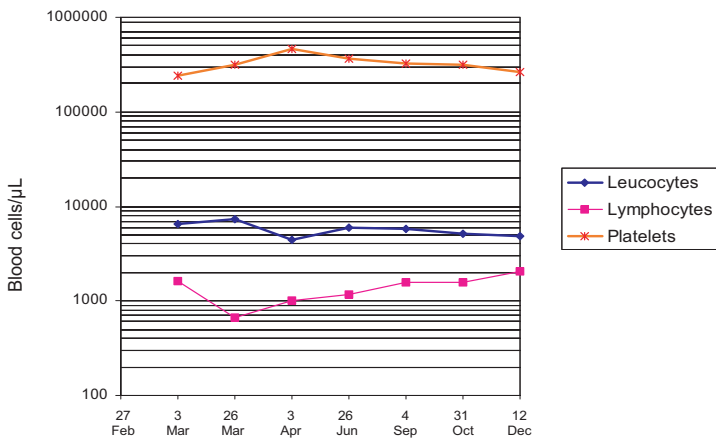
FIG. 34. Haematological chart of Patient 1 after the accident on 27 February 2001.

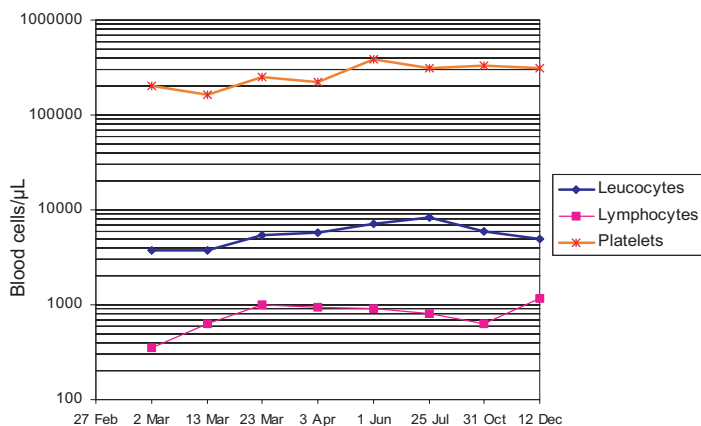
FIG. 35. Haematological chart of Patient 2 after the accident on 27 February 2001.

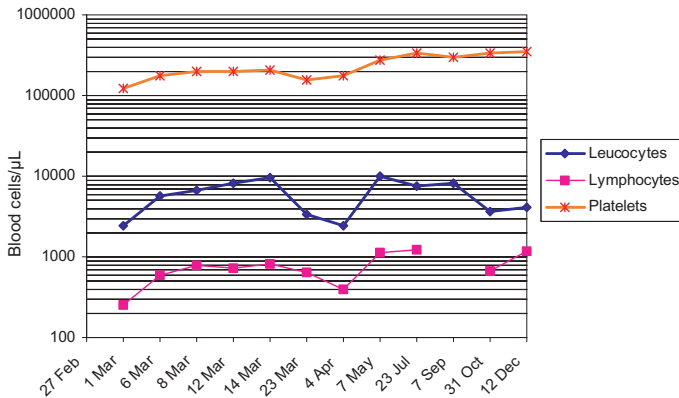
FIG. 36. Haematological chart of Patient 3 after the accident on 27 February 2001.

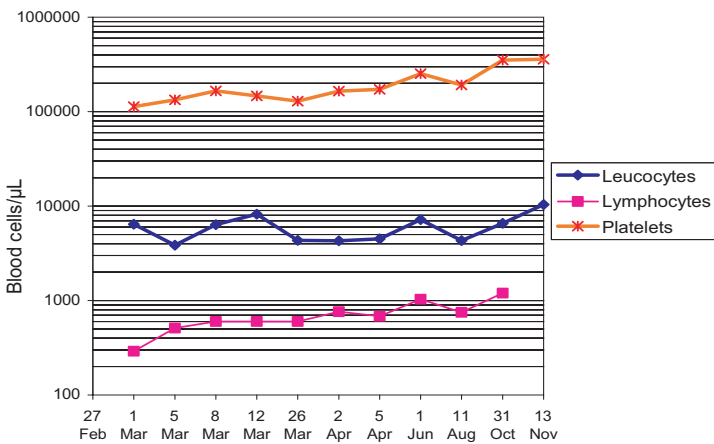
FIG. 37. Haematological chart of Patient 4 after the accident on 27 February 2001.

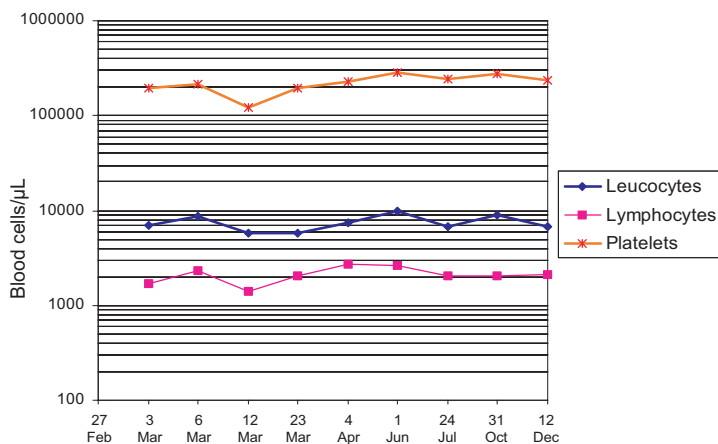
FIG. 38. Haematological chart of Patient 5 after the accident on 27 February 2001.
